温泉施設 付着物の分析試験結果

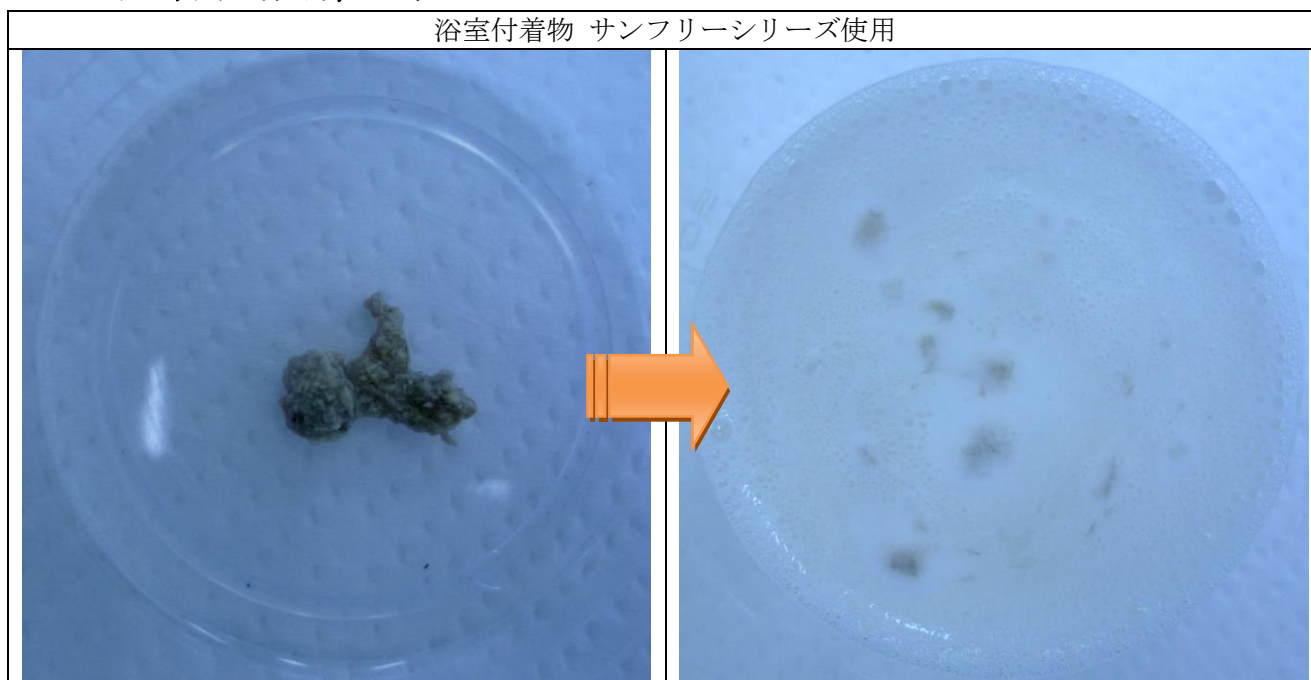
A-2 付着物溶解試験

* 着異物を弊社洗浄剤に 5 分間振とう浸漬後、浴室付着物は発砲溶解が認められた。

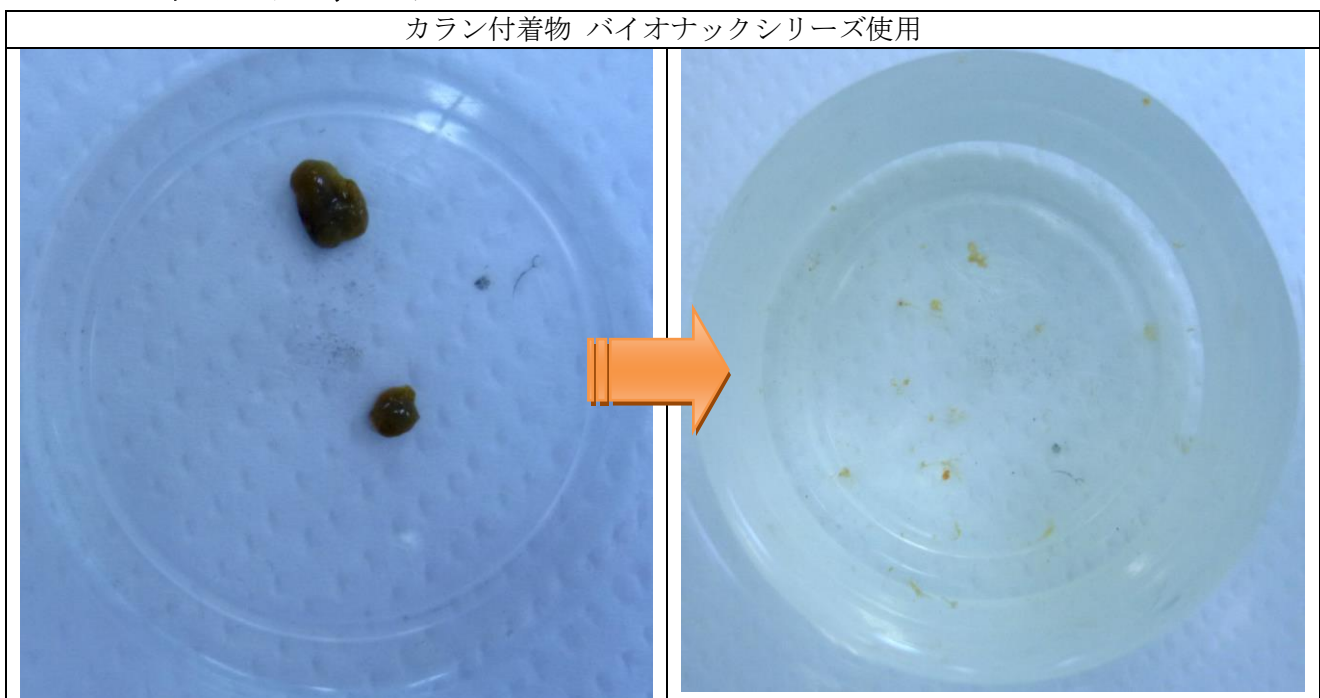
B-2 付着物溶解試験

*カラン付着物を弊社洗浄剤に5分間振とう浸漬後、溶解が認められた。
